*Written for "Safe Buildings for This Century"  
Australian Institute of Building Surveyors  
National Conference, 12 – 13 August 2002  
Darling Harbour, Sydney, Australia*

## **THE WORLD TRADE CENTER AND 9/11: A DISCUSSION ON SOME ENGINEERING DESIGN ISSUES**

Tim Wilkinson

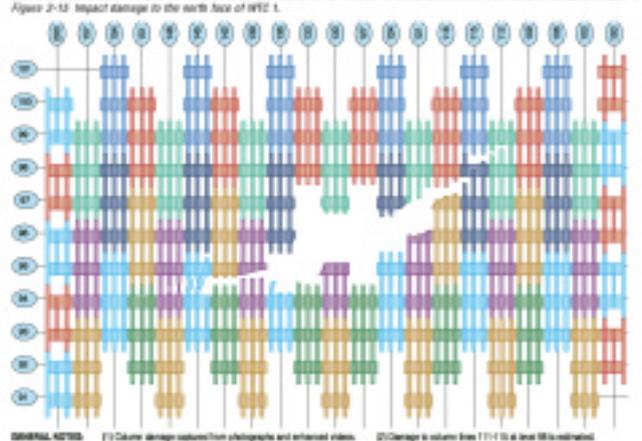
Figure 5: Damage to North Face of WTC 1  
(Source: FEMA report)

The Boeing 767-200ER has a wing span of approximately 48 m, whereas each side of the WTC towers was approximately 64 m. Each impact was roughly centred on a building face, and consequently, as shown in Figure 5, the corners of the building were relatively “unharmd”. However, several of the external columns were completely destroyed. The extent of the damage to the core is unknown. The force of the impact removed a significant amount of the fire retardant from structural elements.
